VIKING LANDER MOSAICS

VIKING LANDER 2 RECTIFIED PHOTOMOSAIC
EVENING SCENE - CAMERA 2 - SECTOR 4

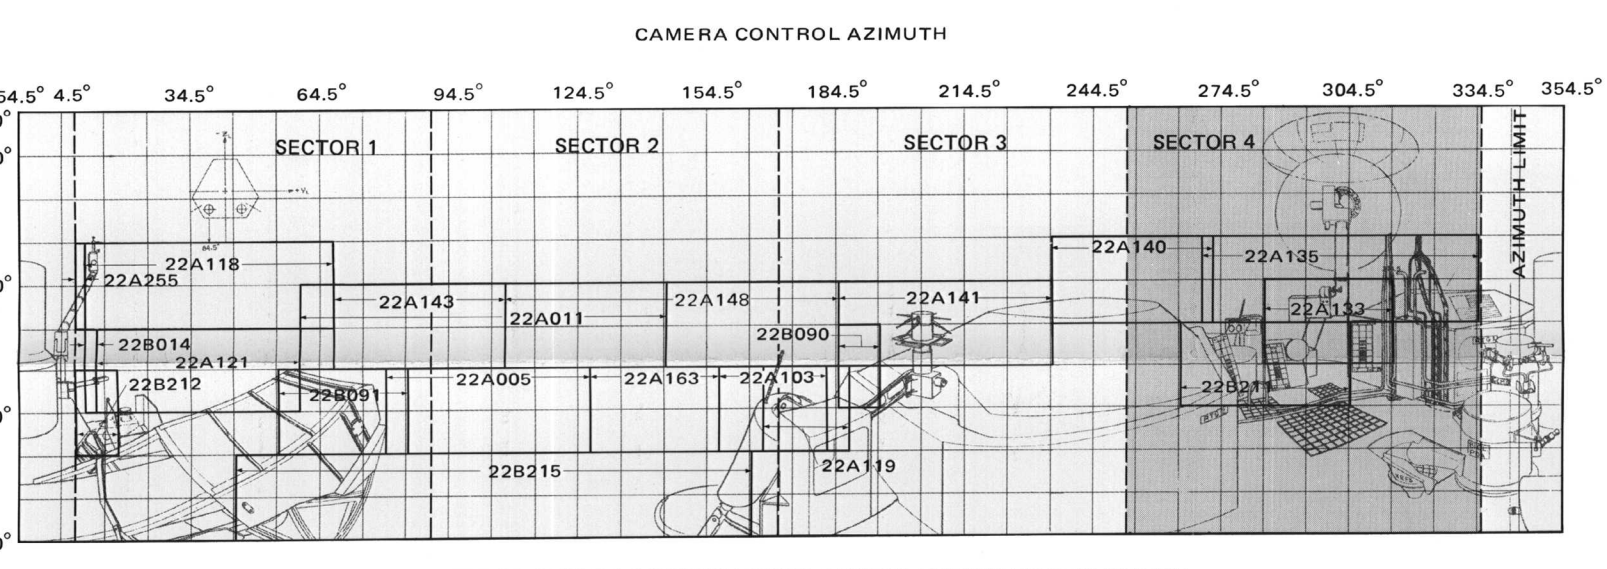
OUTLINE OF CAMERA 2 VIEW SHOWING CAMERA EVENTS USED IN MOSAIC

The Viking Lander cameras acquired many high-resolution pictures of the Chryse Planitia and Utopia Planitia landing sites. Each picture is the product of computer processing on Earth of digital-image data transmitted from Mars as a result of "camera events" carried out by one of the lander camera systems. Further computer processing of data from a selected number of these events yielded a total of 10 mosaics. Two pairs of mosaics from Lander 1 data (one mosaic from each camera) consisted of one pair made from data taken in the morning (0700-0800 hours) and one pair made with data acquired in midafternoon (1400-1530 hours). Similarly, three pairs of mosaics from the Lander 2 data consisted of one pair between 0700 and 0800 hours, one pair at noon, and one pair between 1700 and 1800 hours.

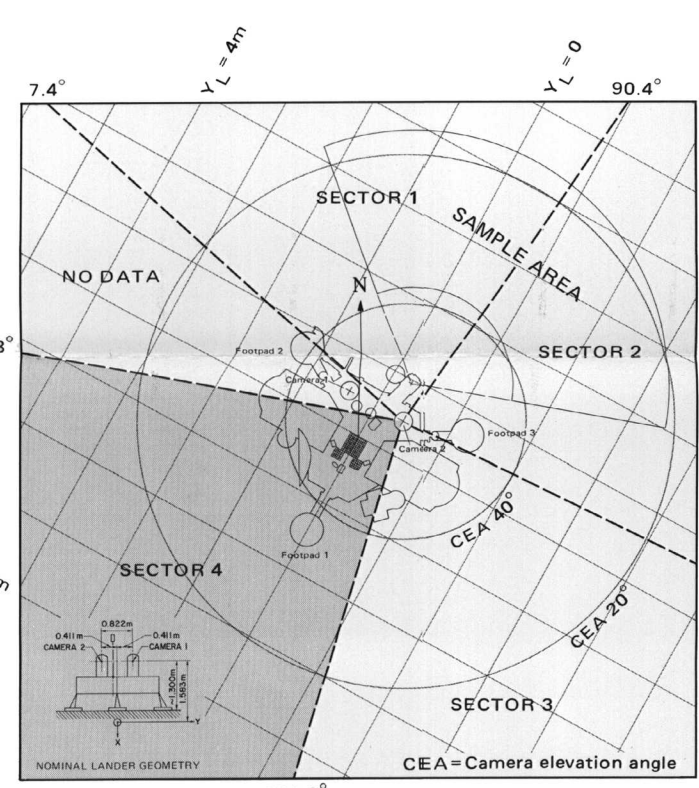
VERTICAL VIEW SHOWING VIKING LANDER 2 ORIENTATION
Grid is in spacecraft coordinates

On September 3, 1976, Viking Lander 2 successfully landed on Utopia Planitia of Mars (47.966° N., 22.572° W.), more than 6500 km northeast of Lander 1 (Mayo and others, 1977; Davies and others, 1978). Lander 2 faces approximately north and tilts 8.2° downward in the direction of 277.4° clockwise from north. The viewing direction of its cameras when pointed in a direction normal to the front of the lander is 29.0° clockwise from north along the horizon. The cameras on Viking Lander 2 operated successfully for 61 days until the primary mission of both landers was completed on November 15, 1976, at solar conjunction.

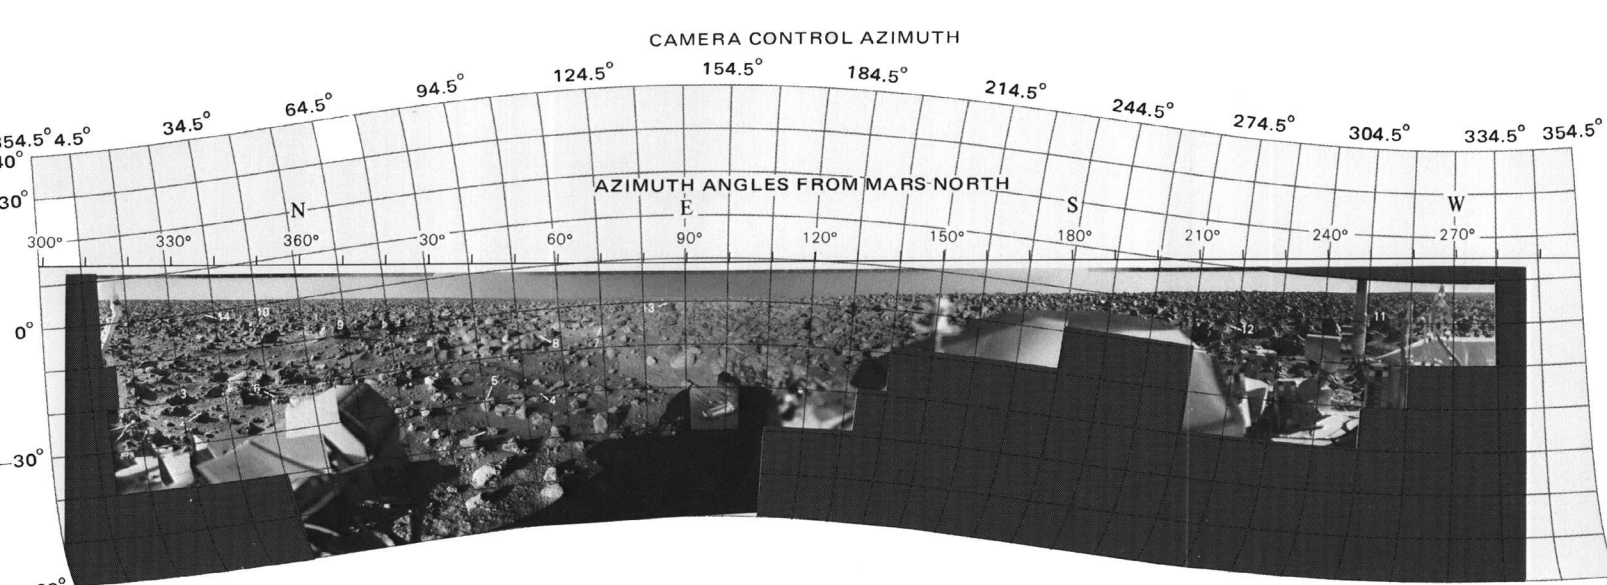
COMPLETE MOSAIC, EVENING SCENE, CAMERA 2
(Corrected for tilt)

This view southwest over the top of the lander shows the same flat-level surface of Utopia Planitia as is viewed in all directions from the lander. The distribution of the large, subangular pitted or vesicular blocks is nearly uniform in all directions out to the horizon. The large blocks appear to be mostly on the surface of fine-grained material. Distributed among the blocks are a few small debris of the fine-grained material. The martian winds have probably scoured and winnowed away the fine-grained material from between the blocks and scattered the debris. Parts of the lander that are seen in the view are from the left: a cover over a Radiosotope Thermoelectric Generator (RTG) (line 350, sample 2300); mounting structure for Leg 1 (line 500, sample 2800); three calibration test charts for the camera (line 600, sample 2600; line 700, sample 2350; line 850, sample 3470); a parabolic mirror for viewing the magnets on the surface-sampler backhoe (line 690, sample 3080); the mast that supports the high gain S-band antenna (line 250, sample 1380); the cover over the other RTG (line 450, sample 4050); tubes and cables that connected the lander to the orbiter during transit to Mars (line 200, sample 3850). Upon command from Earth, the lander separated from the orbiter and performed all of its programmed landing maneuvers under its own power.

The geometry of the lander pictures is complicated by additional factors. Because both landers are tilted with respect to the horizon, on the uncorrected pictures the horizon resembles a sine curve. Computer rectification of the pictures results in a straight horizon along which vertical angles can be measured with respect to the local gravity vector, and horizontal angles can be measured from martian north. These angles are not identical in any simple way to the azimuth and elevation angles given in "camera coordinates" for the uncorrected pictures.
