DESCRIPTION OF SCENE

VIKING LANDER MOSAICS

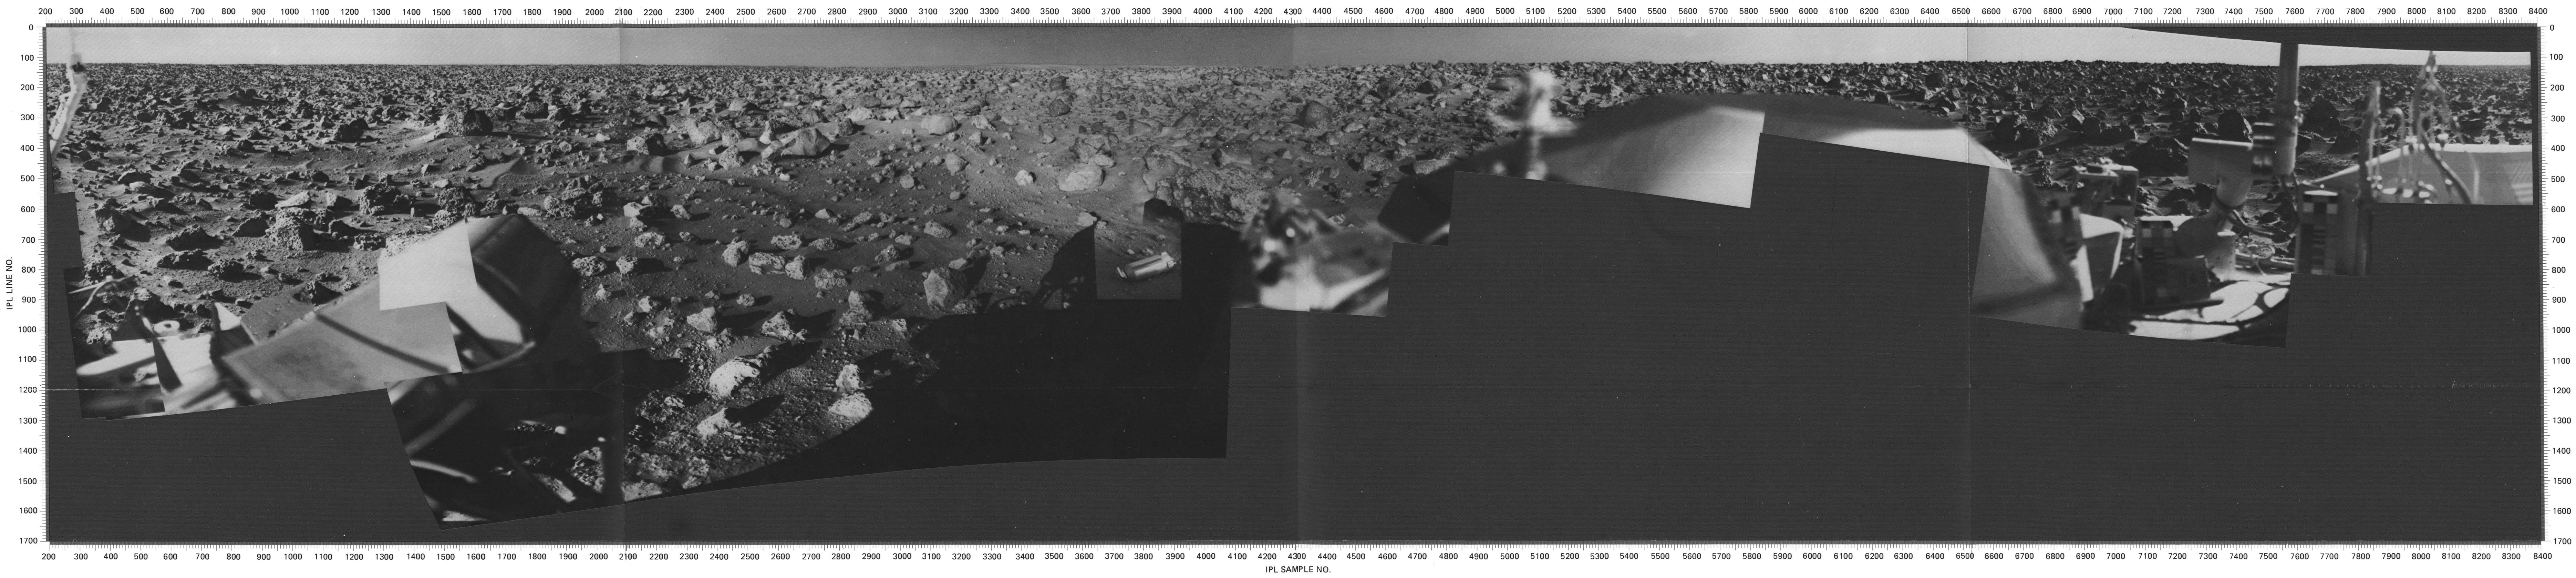
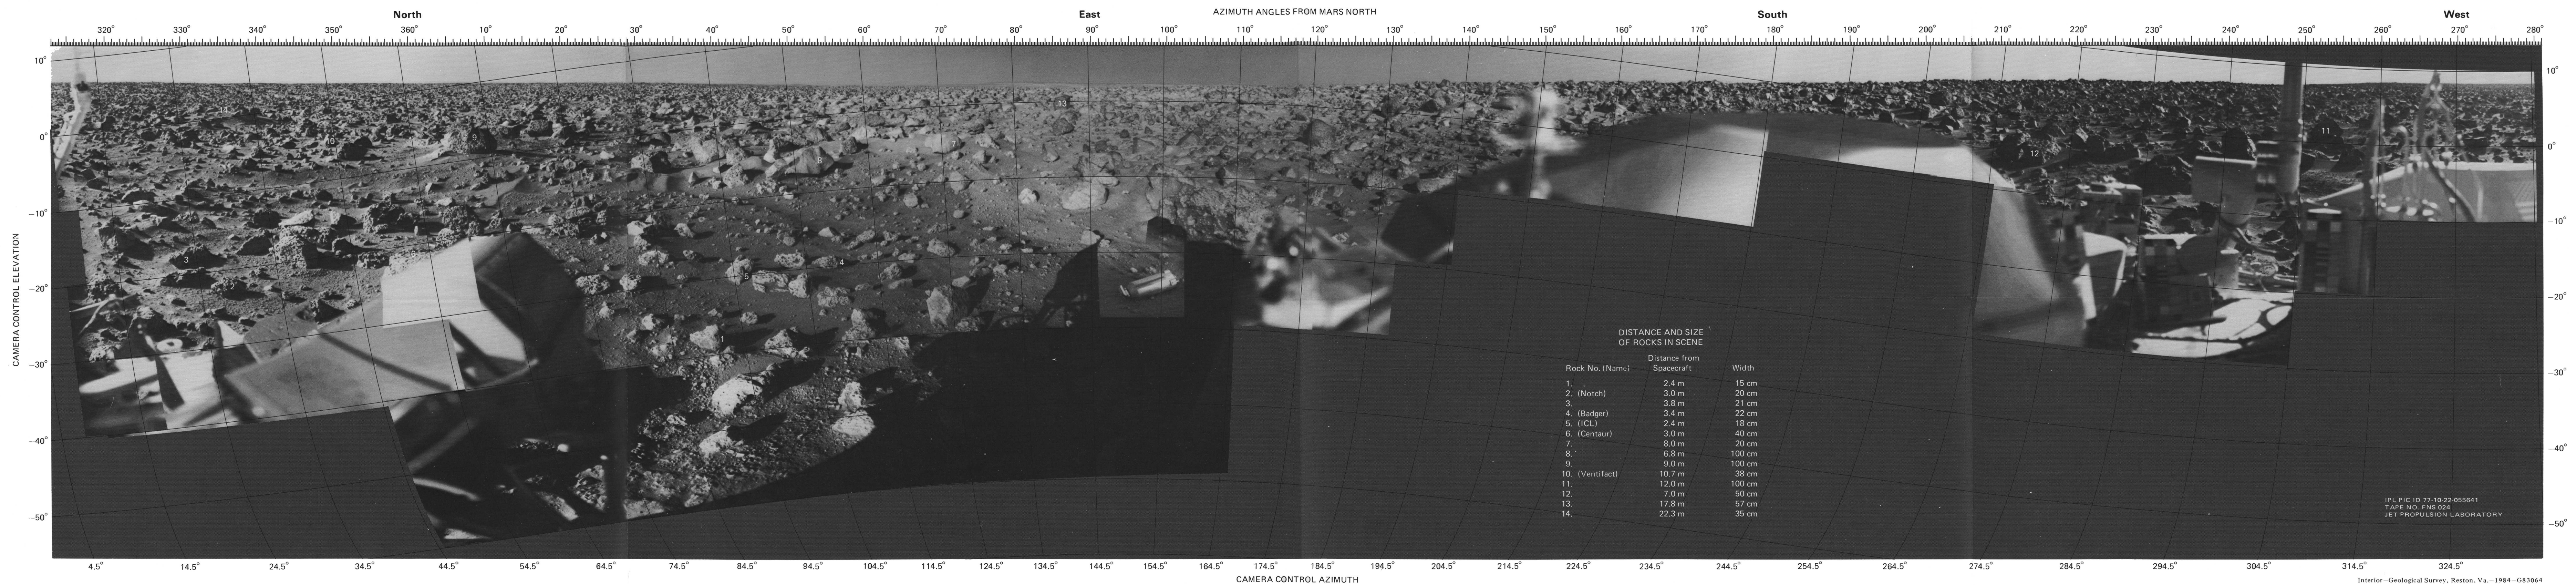
Viking Lander 2 pictures show the flat level plain of Utopia Planitia strewn with rocks in the centimeter to meter size. Most rocks are subangular, equidimensional, and spheroidal. The pits and holes in the rocks, which range from a few millimeters to a few centimeters in diameter, may be voids formed by sublimation from a frothy gas-charged lava. Patches of pebbly fragments (line 1100, sample 3000) and small bits of fine-grained material (line 340, sample 3000) are distributed among the large blocks. The blocks appear to be fairly uniformly distributed out to the horizon. Most of the blocks appear to be on the surface of fine-grained material, probably because of scouring or winnowing of the fine-grained material by the martian winds. Much of the fine-grained material in the interblock areas is bound in a crust which breaks into platy fragments when disturbed (line 1500, sample 2600). About 8 m in front of the lander trending from left to right is a small trough about 1 m wide and 10 cm deep (line 330, sample 300; line 430, sample 3000). Several small drifts of fine-grained material bury parts of the trough (line 480, sample 1700) and occupy its floor. The trough is part of a roughly polygonal network that probably developed from contraction either by cooling of a lava or from thermal expansion or contraction of frost ground.

The cylindrical object (line 800, sample 3800) lying on the surface in the foreground to the right of the spacecraft is a hollow metal canister that covered the surface sampler until after landing on Mars. The canister was ejected from the sampler arm upon command from Earth; it struck a rock near forward 3, bounced, and came to rest in its present position.

Parts of the spacecraft that are visible in the panorama are: meteorological instruments on the end of a boom (line 20, sample 290); the box or housing in which the meteorological instruments were stored during transit to Mars (line 1100, sample 700); the surface sampler (line 800, sample 1600); the true form of the instrument is not shown in this mosaic of pictures that were taken at different times when the instrument was in different positions; mounting structure for leg 3 (line 800, sample 4400); low gain S-band antenna (line 200, sample 3100); cover of a Radioisotope Thermoelectric Generator (RTG) (line 300, sample 5900); three-color test charts used for calibration of the camera (line 650, sample 6800; line 750, sample 7150; line 700, sample 7880); sensorimeter (line 700, sample 6900); mounting structure for leg 1 (line 500, sample 7800); parabolic mirror for viewing magnets on the surface sampler (line 480, sample 7280); mounting structure and mast of the high gain S-band antenna (line 450, sample 7400); and RTG cover (line 450, sample 8200).

The cameras on the Viking Lander acquire data by sampling in equal increments of elevation and azimuth angle. In the accompanying mosaic, 2.0 mm subtended a 1° horizontal or vertical angle, regardless of the place of measurement within the panorama. If the martian surface were flat, one pixel (0.04°) on the surface would be 1 mm wide at 40° camera elevation and 2 m wide at the horizon 3 km away. Characteristically for this type of imaging system, most straight lines in the scene appear curved in the reconstruction. This representation of the picture data differs from that of a conventional camera having "point perspective" picture geometry, in which rays are projected from object space, through the perspective point in the camera lens, to an image plane in the camera. The geometry of the Lander pictures is complicated by additional factors. Because both landers are tilted with respect to the horizon, on the uncorrected pictures the horizon resembles a sine curve. Computer rectification of the pictures results in a straight horizon along which vertical angles can be measured with respect to the local gravity vector, and horizontal angles can be measured from martian north. These angles are not related in any simple way to the azimuth and elevation angles given in "camera coordinates" for the unrectified pictures.

There are other geometric distortions due to the camera: optic path distortion that affects a light ray after it passes the camera window; and camera-system distortions, or "bolt-down" errors, that are caused by the way the cameras are mounted on the lander. The geometric transformation used in creating the mosaics took into account the optic path distortion but not the "bolt-down" errors. However, along the horizon, the error in azimuth angle is equal to the rotational "bolt-down" error for each camera to an accuracy of less than 1 pixel. The scale "azimuth angles from Mars north" has been adjusted to take into account this correction.

The residual azimuthal angle errors are less than 1 pixel along the horizon and become larger with steeper elevation angles and larger lander tilts. For the worst case, Lander 2, camera 1, this error is a maximum of 5.7 ± 1 pixels at 40° elevation. The somewhat sinusoidal azimuth-dependent residual elevation error is a maximum of 3 ± 1 pixels for Lander 2, camera 1, and approximately 1 pixel for the other camera.
