IPL PIC ID: 77-10-12-14601
TITLE: NO. 018
JET PROPULSION LABORATORY

COMPLETE MOSAIC, EVENING SCENE, CAMERA 2
(Corrected for tilt)

VIKING LANDER MOSAICS

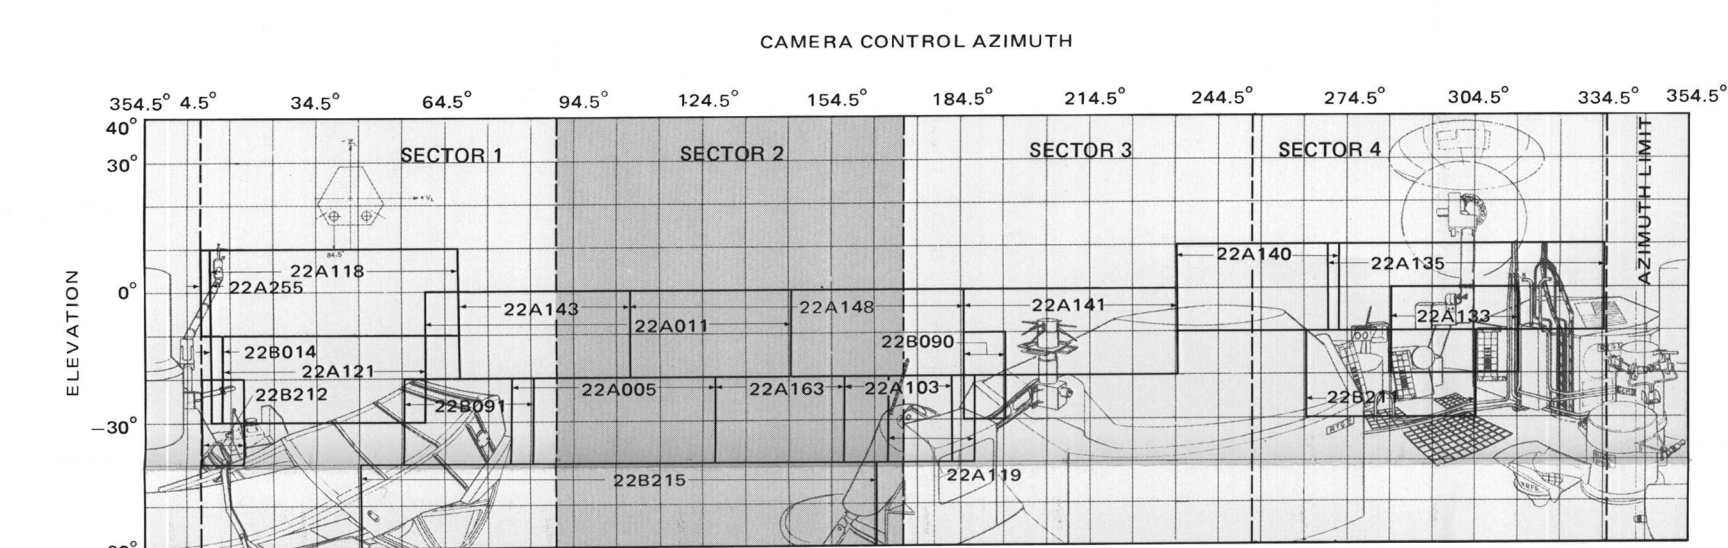
OUTLINE OF CAMERA 2 VIEW SHOWING CAMERA EVENTS USED IN MOSAIC

Procedures used for processing the Viking Lander camera data were described by Levinthal and others (1977). The individual camera events used in each mosaic file identified in the outline of the accompanying camera view. Detailed description and reproductions of these camera events were given by Tucker (1978). Copies of the Viking Lander pictures can be obtained from the National Space Science Data Center, Goddard Space Flight Center, Greenbelt, MD, 20771.

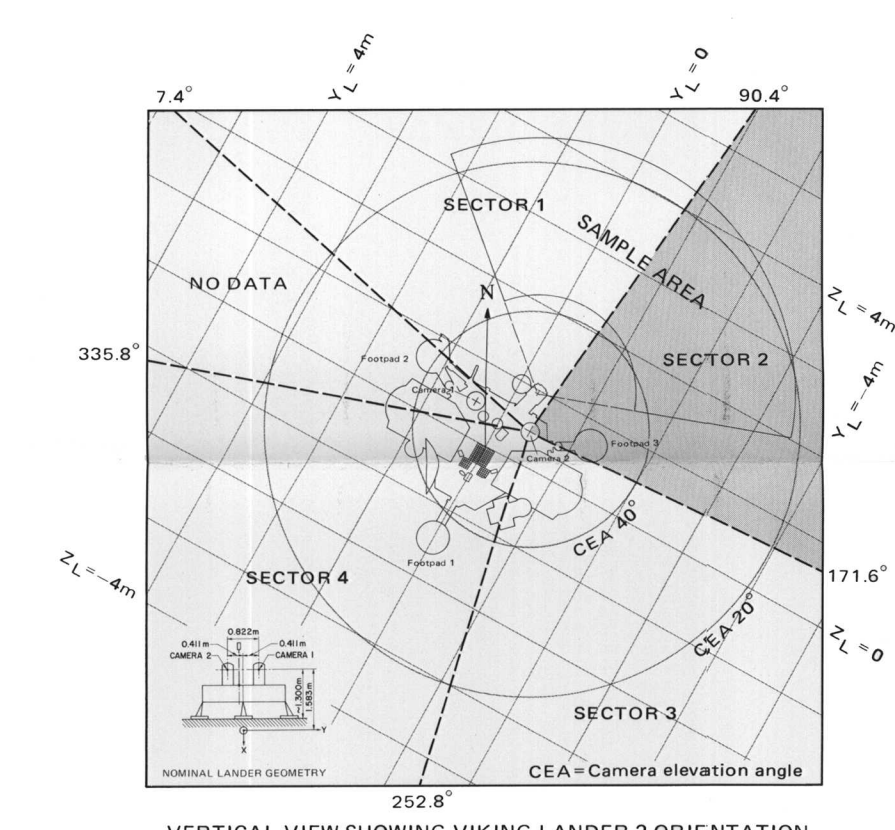
VERTICAL VIEW SHOWING VIKING LANDER 2 ORIENTATION
Grid is in spacecraft coordinates
