DESCRIPTION OF SCENE

THE VIKING MISSION

VIKING LANDER MOSAICS

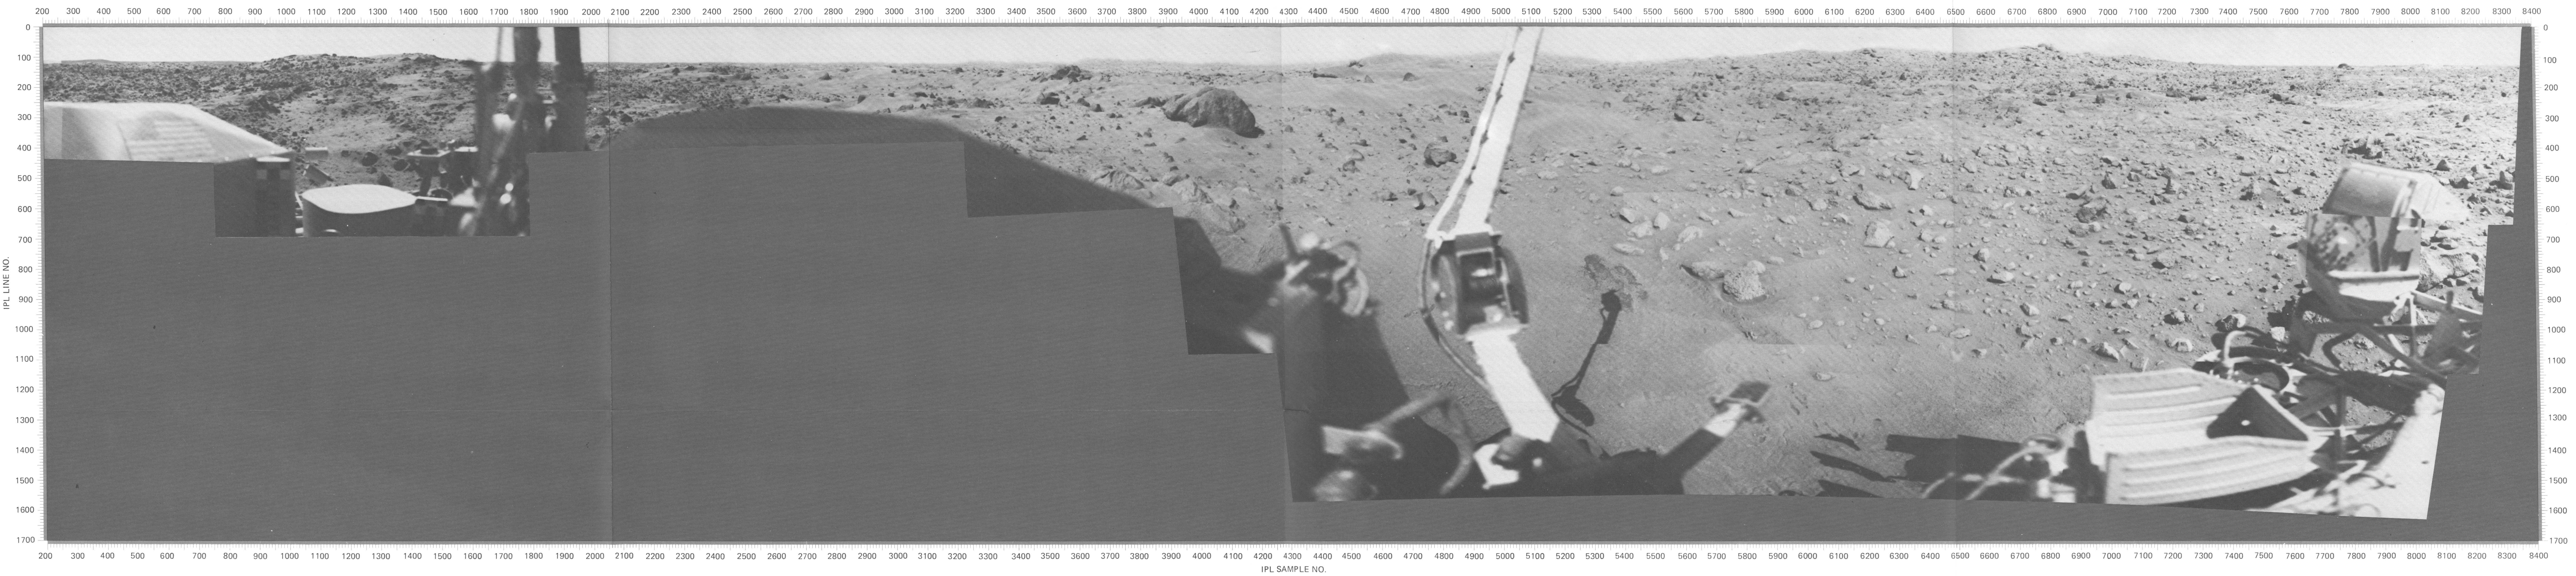
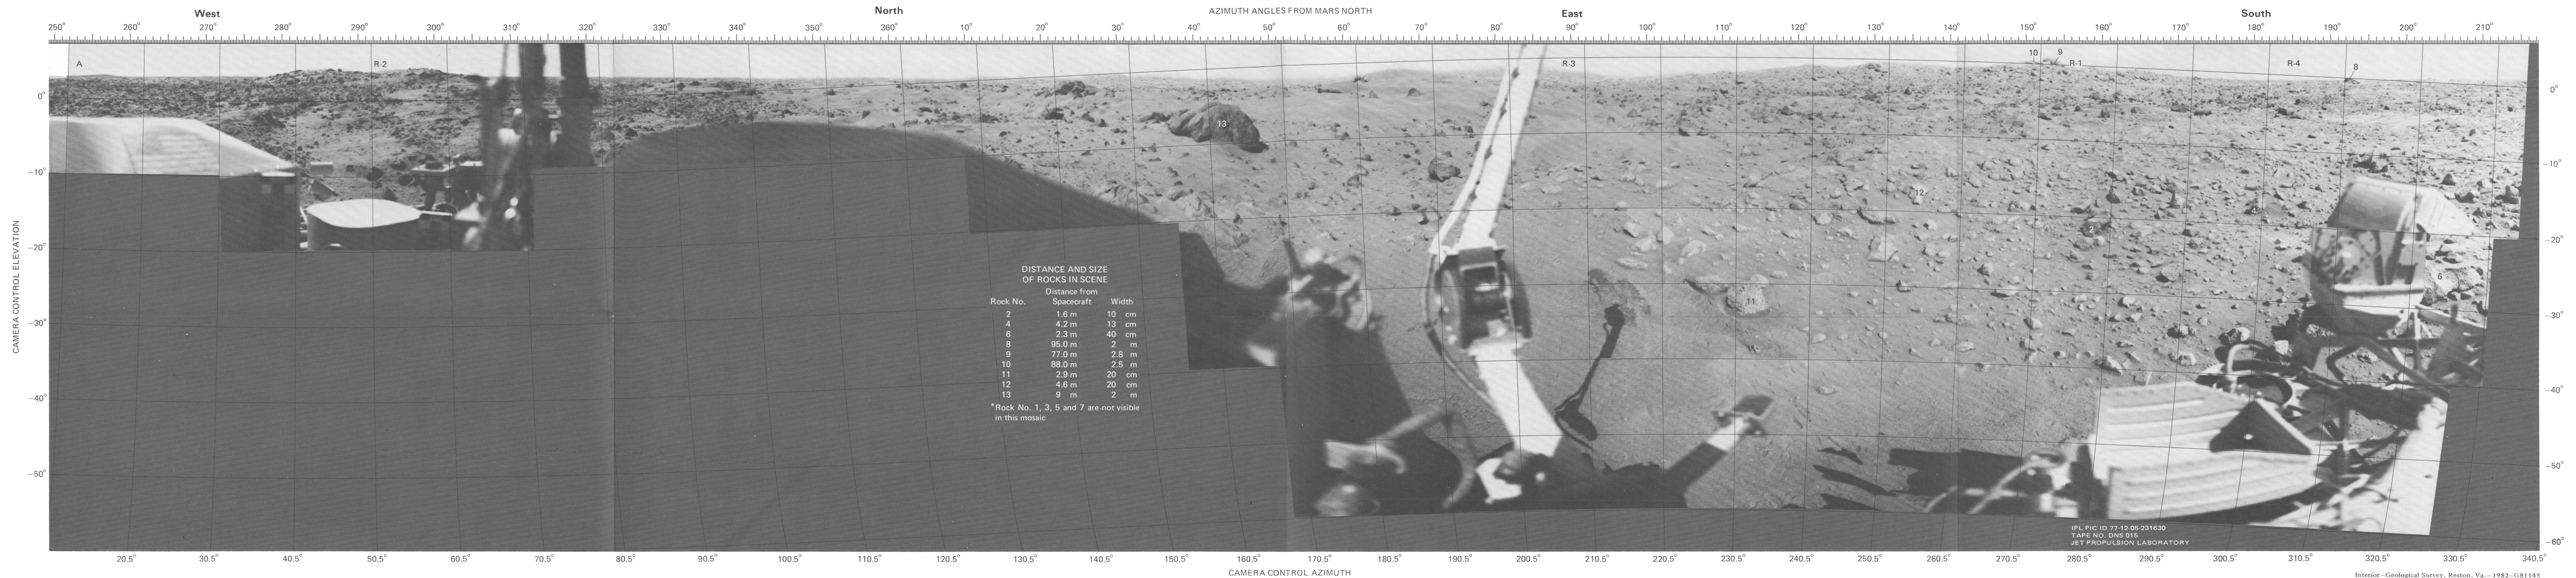
A panorama of Chryse Planitia landing site shows a varied landscape. The surface is strewn with rocks in the centimeter to meter-size range. Large drifts of red, very fine grained (about 100 μ m), "dusty" material dominate the center of the scene (line 330, sample 5200); they are probably remnants of a thicker layer of fine-grained material that has been swept away by the wind. Footprint 2 of the lander (line 1400, sample 4800) is buried to a depth of 16.5 cm in one of the drifts. Small rock fragments blown out by the exhaust of the rocket engines during landing have made pits and tracks (line 1250, sample 3960) in the dusty material. Also, the jarring of the surface by the lander during touchdowns formed cracks in the surface of several drifts (line 1382, sample 5920). A large rock that has been split in two parts in the center of the scene (line 250, sample 4050) has a cap of the dusty material. The rock is about 2 m across and about 9 m from the lander.

Viking Lander 1 rests on the martian surface between two small craters whose rims form prominent ridges on the horizon. (See Viking Orbiter picture to the right). The rim of crater H (line 100, sample 1250), about 100 m in diameter, forms a ridge about 50 m west of the lander. The lander is tilted downward 3° in this direction. Southeast of the lander, the rim of Crater C, about 150 m in diameter, forms the horizon about 80 m away. Several blocks (line 66, sample 6800) as large as 3 m across rest on this rim. One of several wrinkle ridges, known as "White Mesa" (line 80, sample 5200), forms the horizon about 1.2 km east of the lander.

Most picture-taking sequences for the Viking cameras were planned to include as much of the martian surface as possible. However, the camera could not avoid some parts of the lander. Those parts that are visible in the panorama, from left to right, are: cover of one of two Radioisotope Thermoelectric Generators (RTG) (line 340, sample 690); 11H relay antenna (line 426, sample 1100); one of three photometric calibration charts for the cameras (line 600, sample 950); solenometer (line 580, sample 1200); upper mounting structure and stroke gauge of leg 1 (line 420, sample 1600); mast of the high-gain 3-horn antenna (line 100, sample 1920); cover of the second RTG (line 550, sample 2700); upper mounting structure and stroke gauge of leg 2 (line 800, sample 4300); shock absorber of leg 2 (line 1000, sample 4500); meteorology boom (line 400, sample 5000); mast cleaning brush (line 1200, sample 5800); and part of the surface sampler instrument (line 700, sample 7750). The lower-most edge of the scene is about 1.7 m from the camera.

A trench dug by the surface sampler for soil analysis on board the lander is visible near the center of the scene (line 800, sample 5300) to the right of the hinge of the meteorology boom. It is about 8.5 cm wide and 70 cm long.

The cameras on the Viking Lander acquire data by sampling in equal increments of elevation and azimuth angle. In the accompanying mosaic, 2.9 mm subtends a 1° horizontal or vertical angle, regardless of the place of measurement within the panorama. If the martian surface were flat, one pixel (0.64° on the surface) would be 1 mm wide at 40° camera elevation and 2 m wide at the horizon 3 km away. Characteristically for this type of imaging system, most straight lines in the scene appear curved in the reconstruction. This representation of the picture data differs from that of a conventional camera having "point perspective" picture geometry, in which rays are projected from object space, through the perspective point in the camera lens, to an image plane in the camera.

The geometry of the Lander pictures is complicated by additional factors. Because both landers are tilted with respect to the horizon, on the uncorrected pictures the horizon resembles a sine curve. Computer rectification of the pictures results in a straight horizon along which vertical angles can be measured with respect to the local gravity vector, and horizontal angles can be measured from martian north. These angles are not related in any simple way to the azimuth and elevation angles given in "camera coordinates" for the unrectified pictures.

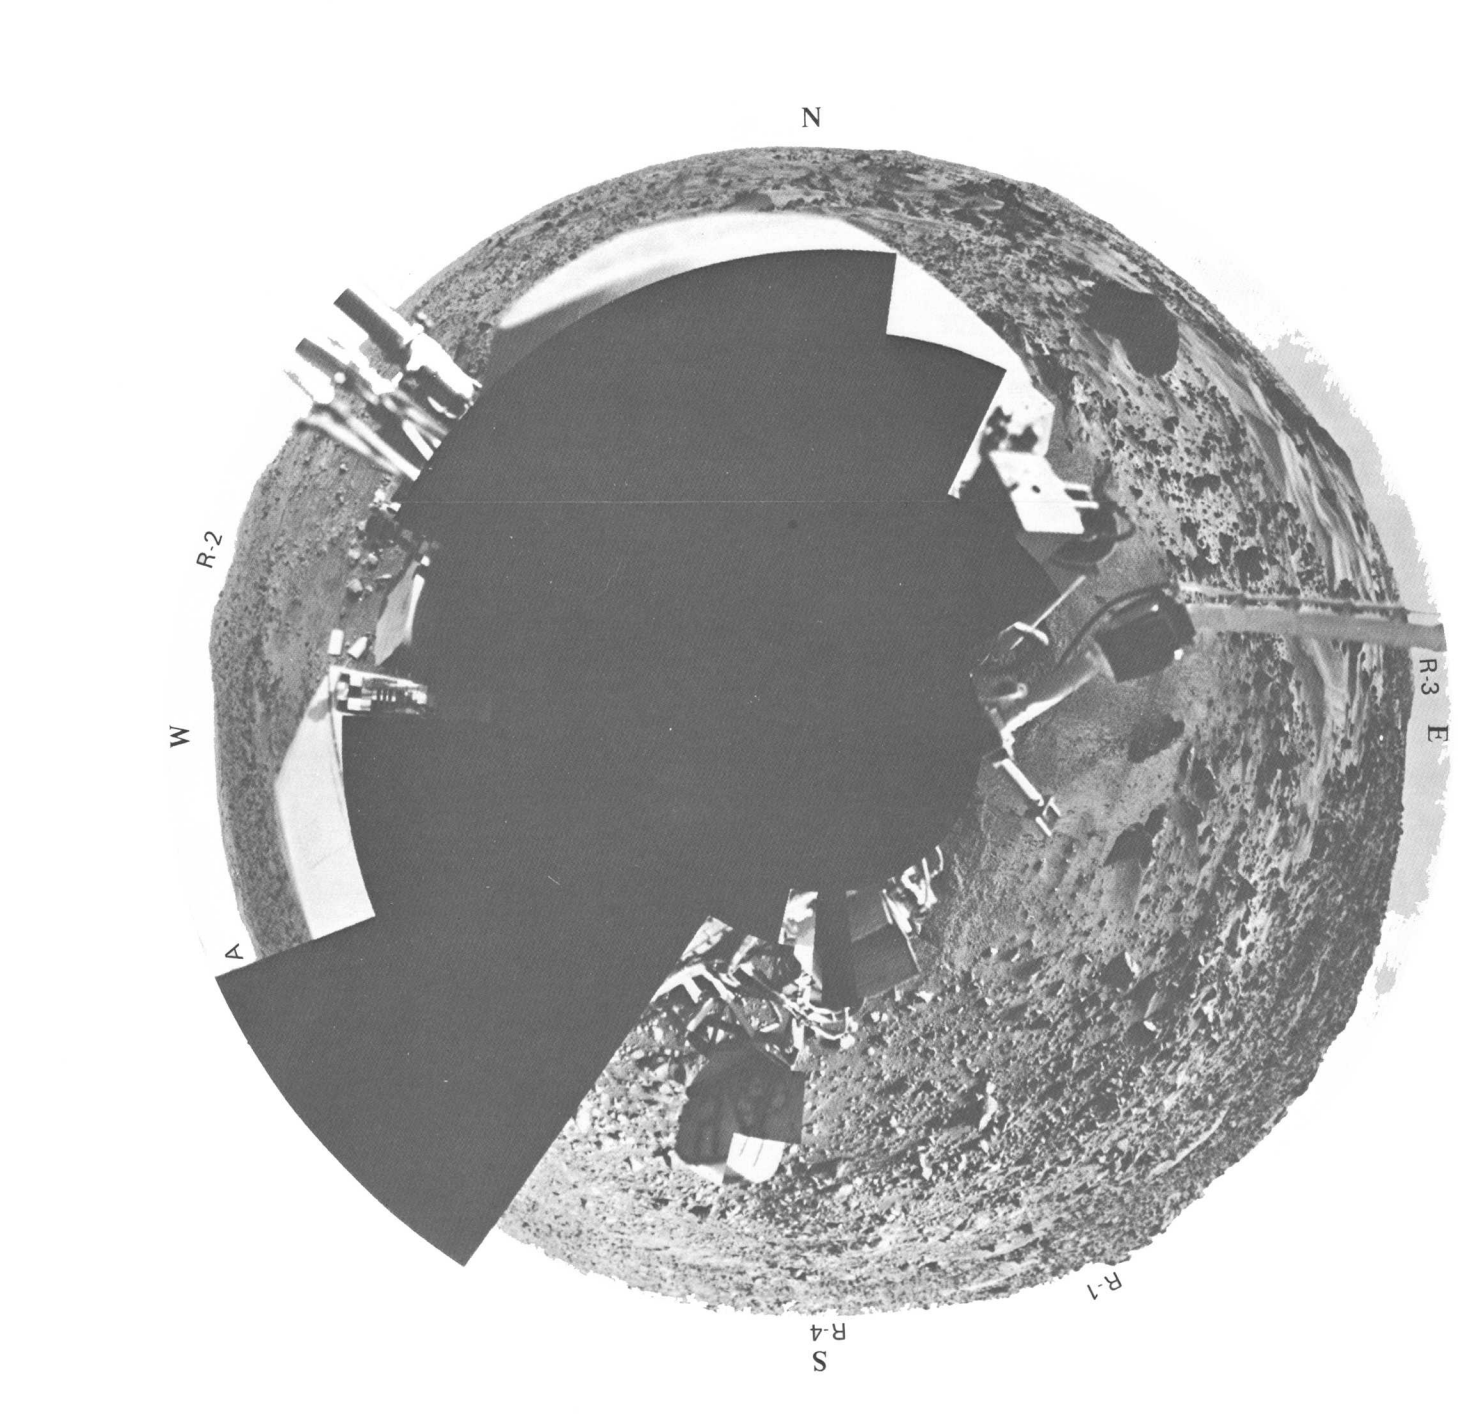
A high-resolution (lander mosaic) was transformed to produce the denotative presentation of the horizon. Lander fit was removed from the projection. A second transformation was used to connect elevation angles relative to the local vertical to a radius function and azimuth relative to north to a circular function. The result is a polar stereographic projection with the property that camera distortions resulting from different sampling at different elevations are removed. I.P.L. Picture I.D. 78/01/03/185404.

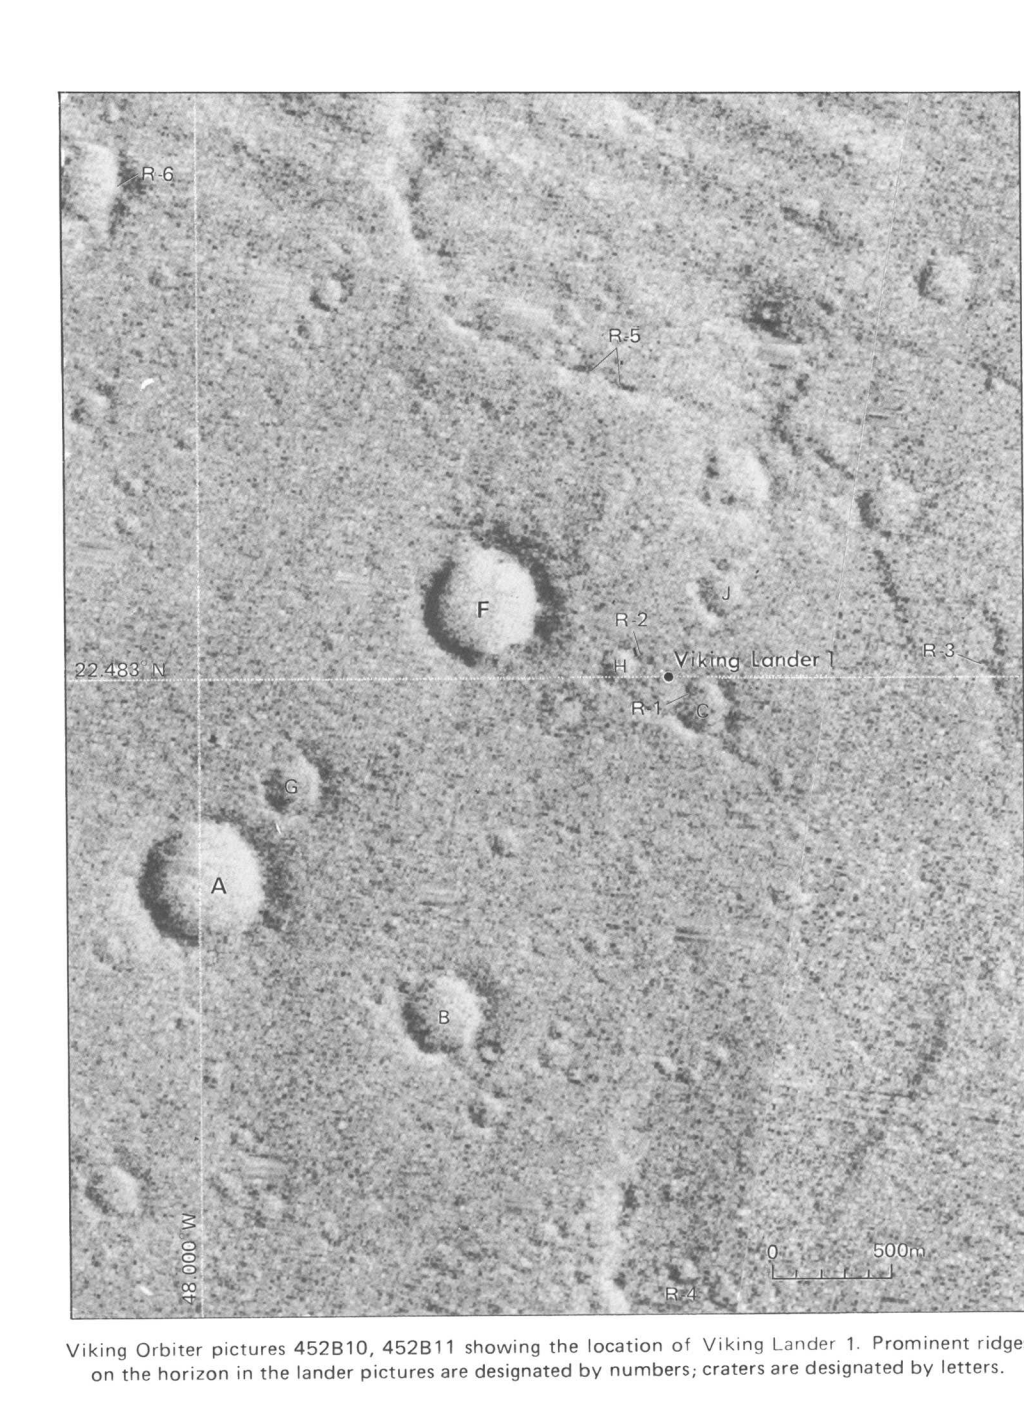
Viking Orbiter picture 452810, 452811 showing the location of Viking Lander 1. Prominent ridges on the horizon in the lander pictures are designated by numbers; craters are designated by letters.
